# Use of Vacuum-Assisted Closure (VAC) along with Integra® Wound Matrix after a transtatarsal amputation (TMA) following an accident caused by a mower – a case study

Ignarska J, Ignarska M, Bachurska DM, Czach ZM, Ignarski M, Tchórzewski S, Latański M, Danielewicz A. Use of Vacuum-Assisted Closure (VAC) along with Integra® Wound Matrix after a transtatarsal amputation (TMA) following an accident caused by a mower – a case study. Ann Agric Environ Med. doi:10.26444/aaem/240304

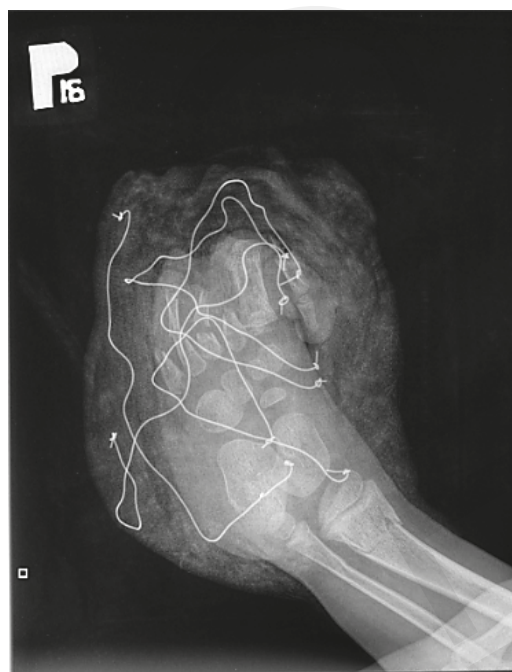
**Figure 1.** Preoperative X-ray of the right lower limb. The image reveals fractures of the distal metaphysis of the tibia and fibula, along with extensive traumatic amputation of the metatarsals II–V and the first toe at the metatarsophalangeal joint

A 2-year-old girl was urgently admitted to the Paediatric Orthopedics Clinic due to an accident with a mower. As a result, the patient experienced transtatarsal amputation and a fracture of the distal metaphysis of the right tibia (Fig. 1). The patient had no comorbidities. A severed foot fragment of the right foot which included 3 toes and a fragment of the metatarsus, was brought in an ice bag but was not suitable for replantation. X-ray revealed fractures of the distal metaphysis of tibia and fibula, amputation of metatarsals – II and V in the proximal part, III and IV in the distal part of the right foot, fractures of the shafts of metatarsals III and IV, and the proximal metaphyseal of 1st metatarsal of the right foot, and amputation of toe I in the metatarsophalangeal joint. The hallux of the right foot was dislocated, a skin strip with torn tendons, except for the hallucis flexor and hallucis extensor, remained attached (Fig. 2). The hallux was not

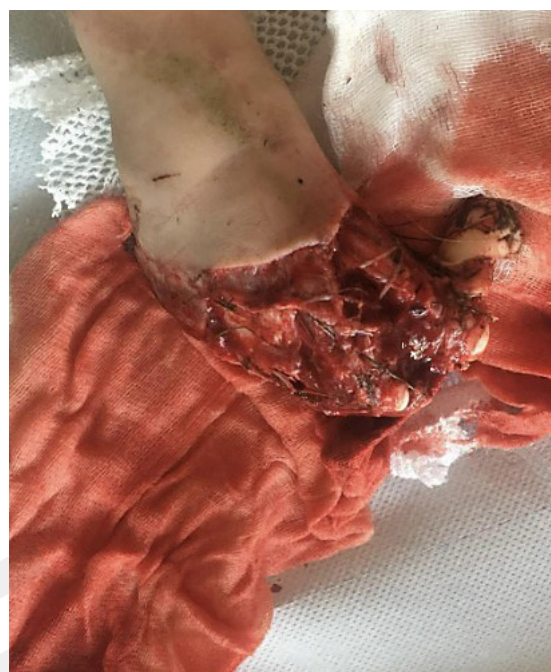
**Figure 2.** Clinical presentation of the right foot upon admission. Severe degloving injury (scalping) of the metatarsus reaching the level of the Chopart joint, following a lawnmower accident

replanted due to the small diameter of the blood vessels. The metatarsus were scalped to the level of the Chopart joint, which created an extremely challenging case, as transmetatarsal amputations themselves are considered at high risk of subsequent amputations.

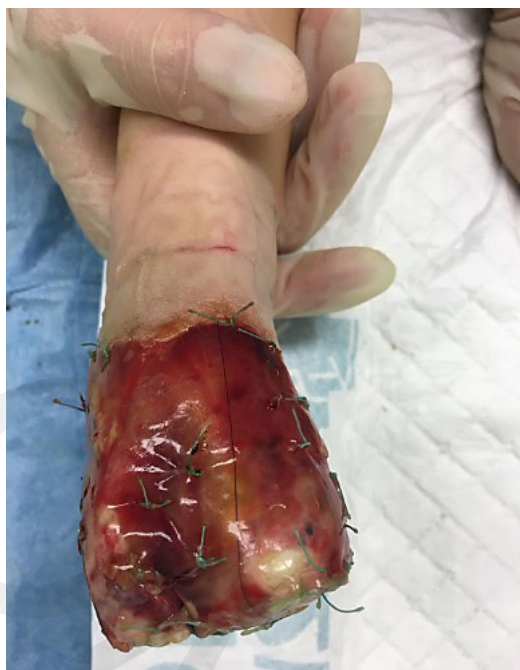
**Figure 3.** Intraoperative application of Integra® Wound Matrix. The 2mm bovine collagen and silicone bilayer matrix was placed directly onto the debrided stump to promote revascularization and provide a foundation for subsequent grafting

An operation was performed the same day, surgical debridement of the wound carried out, and a closed reduction of the fracture of the distal metaphysis of the right tibia performed with percutaneous Kirschner wires fixation. After the surgical debridement of the stump and rinsing it with 0.9% NaCl saline, Integra® Wound Matrix (Fig. 3) was placed directly on the remains of the foot. The VAC system was then applied at the negative pressure of 100mmHg. Moreover, perforations were cut in the Integra® Wound Matrix for better access to take smears, and to allow better under-pressure penetration. Subsequently, a plaster splint was placed on the limb.

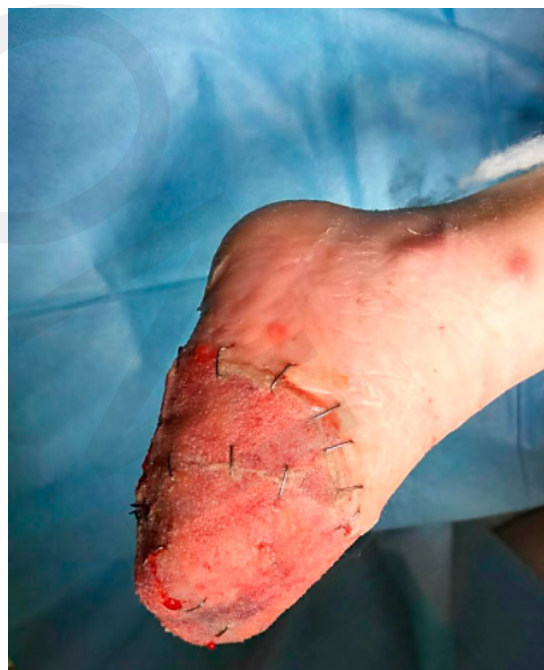
**Figure 4.** Postoperative view after autogenous split-thickness skin graft (STSG). The graft was fixed with surgical staplers over the integrated collagen matrix and protected by a silicone dressing and the Vacuum-Assisted Closure (VAC) system

On the 26th day, when the Integra® changed colour from pink to vanilla, it was removed. An autogenous skin transplant from the front of the right thigh to the right foot was performed using an electric dermatome. The autogenous split-thickness skin transplant was fixed directly on the new Integra® Wound Matrix with staplers. A silicone dressing was placed on the skin graft layer to avoid direct contact of the skin transplant with the VAC system, which was then placed on top. After the skin transplant, the VAC was kept in place for 5 days (Fig. 4). Also on day 26, Kirschner wires were removed.

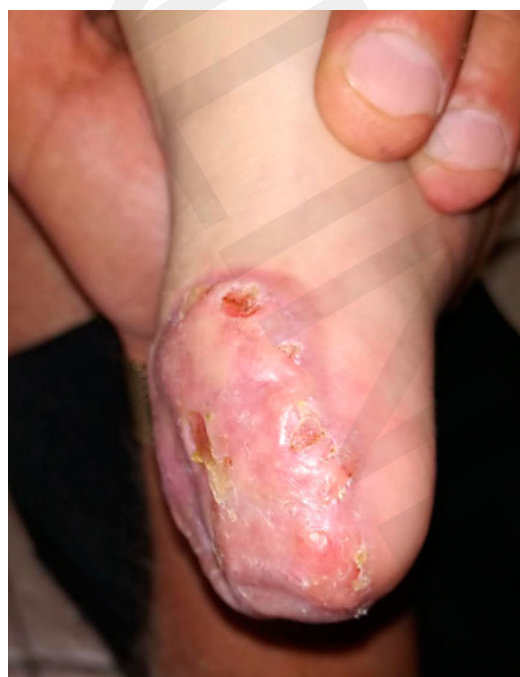
**Figure 5.** Clinical outcome at the 6-year follow-up. The stump is fully healed with no additional deformities. The patient exhibits a symmetrical gait and normal physical development for her age

The plaster splint was taken off (Fig.5) and the patient discharged home in good general condition with recommendations for general care.

On the 6-year follow-up, the stump has healed, and no additional deformities of the stump were observed. The length of the limbs is equal, the gait symmetrical, without any limping. The dorsiflexion of both feet is comparable. The patient does not use any prosthesis for everyday life, and development is within the normal developmental age range; moreover, the patient attends school without any limitations.
